Smartab STJR700 Charging Port Replacement

Replacing charging port on Smartab STJR700 children's tablet.

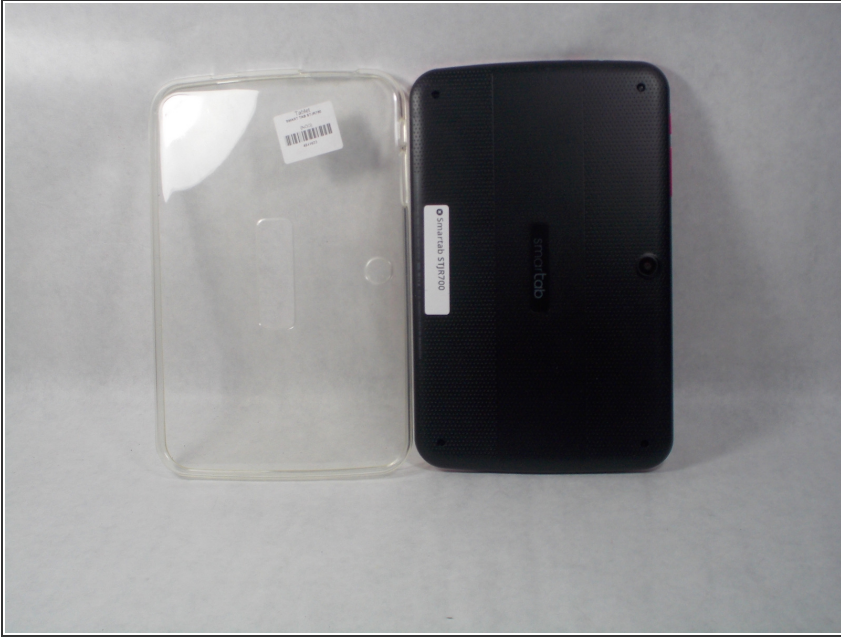
Step 1 — Charging Port

- Hold the lock button and power off the device. Remove the case from the tablet and place it face down.

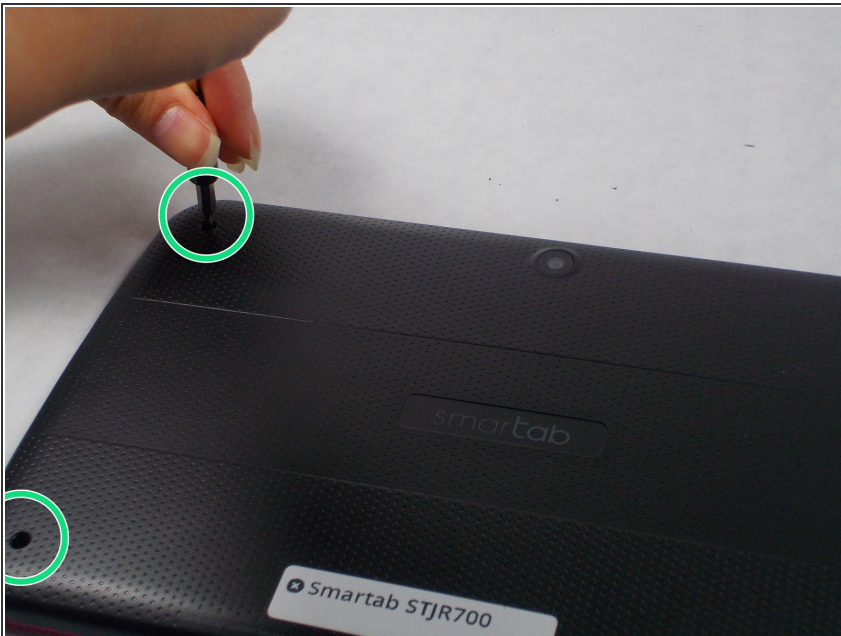
Step 2

- Unscrew all four corner screws with a PH000 screwdriver head that can be found in the iFixit kit.

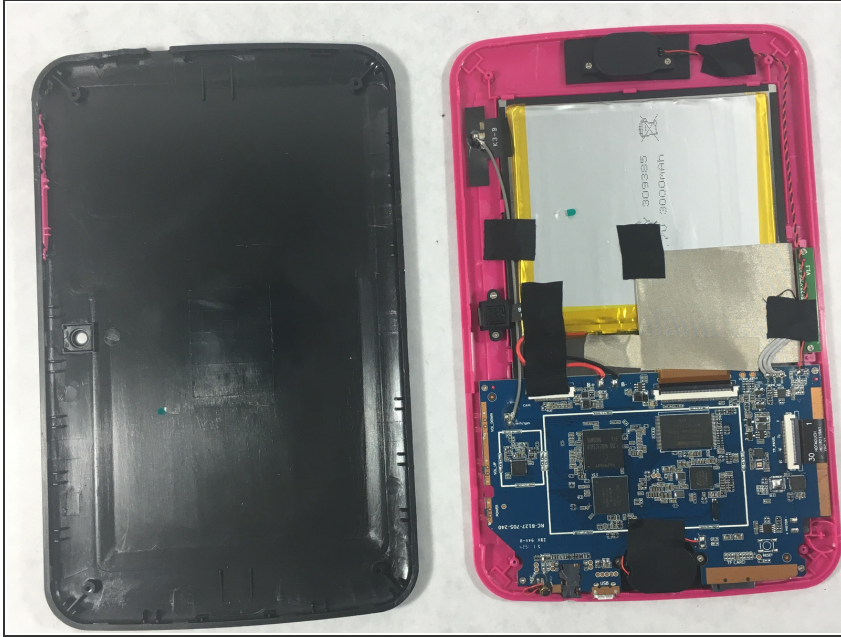
Step 3

- Pry open the tablet using a metal spudger. Be careful and avoid touching the display. When the back panel is removed, set it aside.

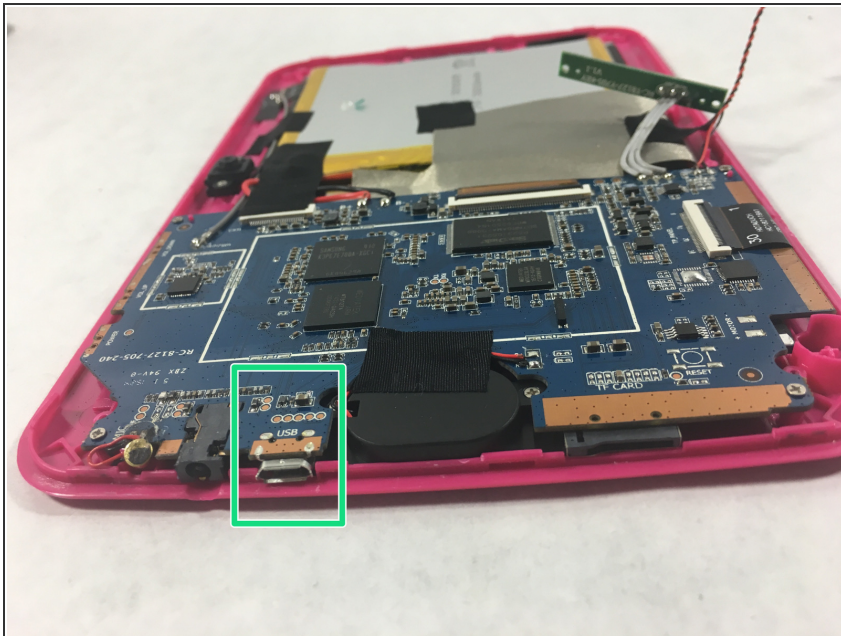
Step 4

- Locate the charging port.

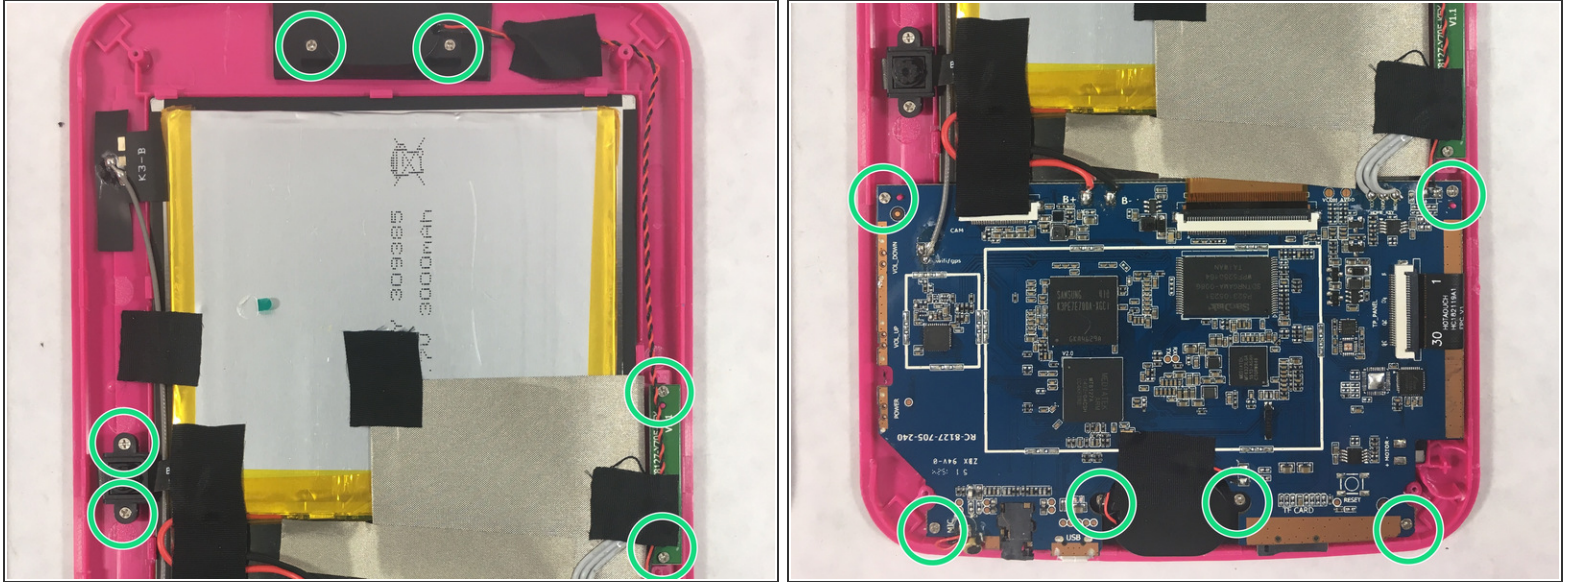
Step 5

- Unscrew all the labeled screws using the PH000 screwdriver head.

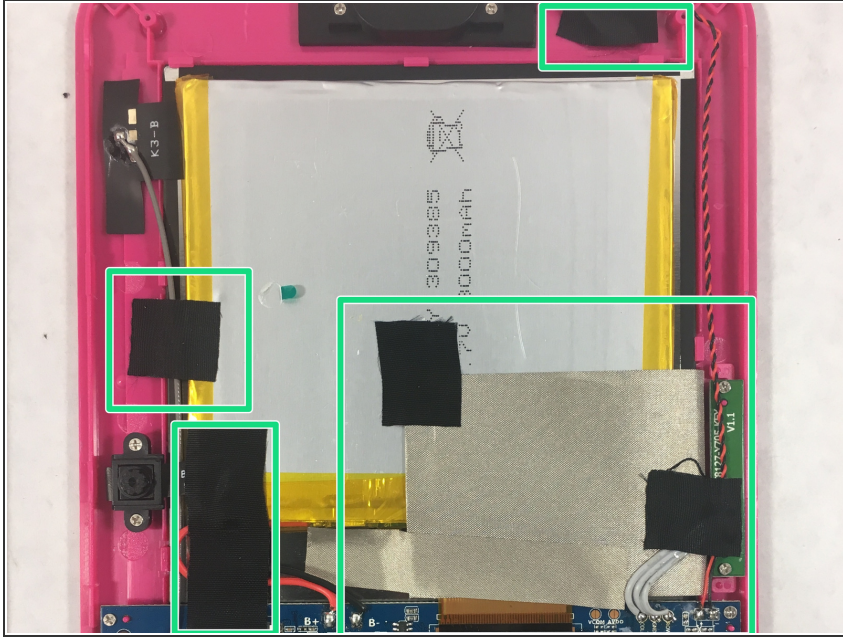
Step 6

- Use the tweezers provided in the iFixit kit and remove all pieces of tape and ribbon cables. When you come across the ribbon cable near the camera, carefully remove the two components that allows the camera to stay put.

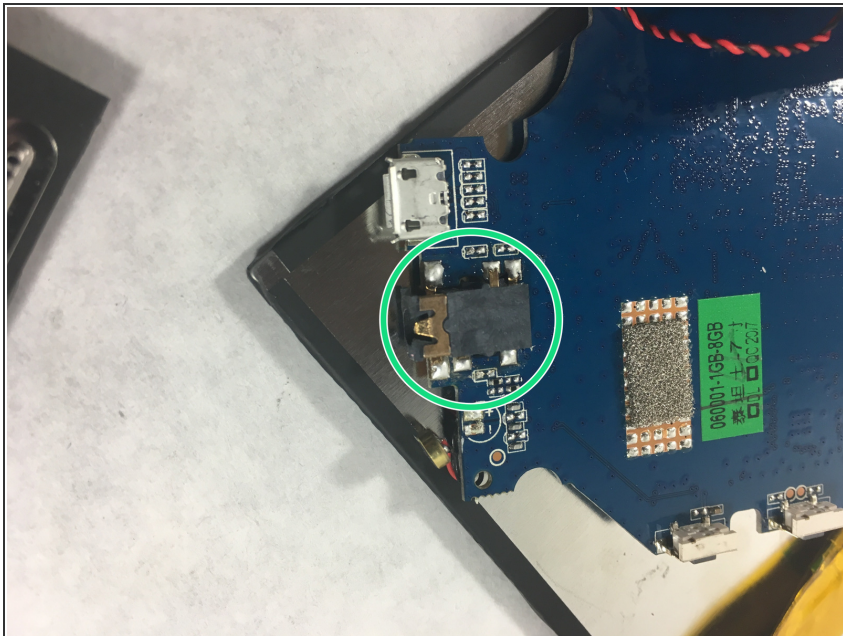
Step 7

- Remove the motherboard component from the screen and display.

- In the previous step, you can see that the charging port is soldered in the motherboard. You can't do much since it required heat to fuse together the alloys. You can order a new motherboard specifically made for the Smartab STJR700. You can easily replace it.
